BY LORRAINE D. DOUCET AND FORREST THORNTON

Stainless steel vs. brass faucets: A study

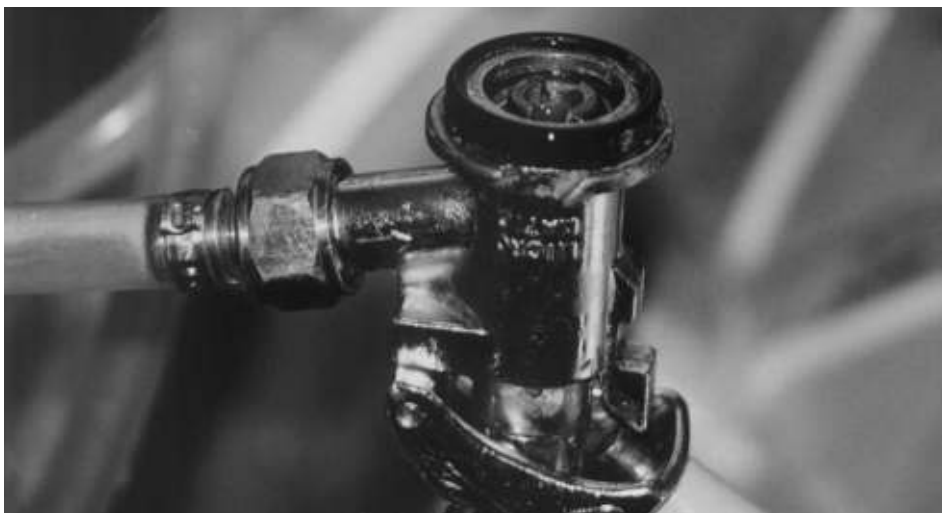
Photo 1. Keg coupler revealing brass surface

Examination of traditional chrome plated keg couplers, "Y" wall brackets, shanks, and faucets revealed that the chrome was completely eroded thus exposing the beer to the porous brass which contained many pitted areas (see photos 1, 2 and 3).

Erosion of copper and lead from a chrome plated brass dispensing system and components were evident in this study. Plates 1, 2 and 3 show erosion of the chrome plating and pitted areas within the interior of the brass keg coupler and faucet. Tables 7, 8 and 9 indicate leaching of the copper and lead from the brass alloy which altered the organoleptic quality of the beer as indicated by the taste test conducted in this study.

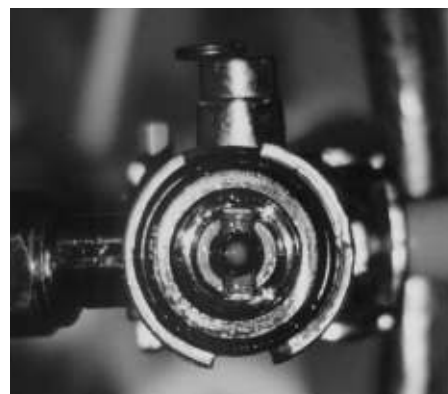
Photo 2. Pitted brass surface of keg coupler

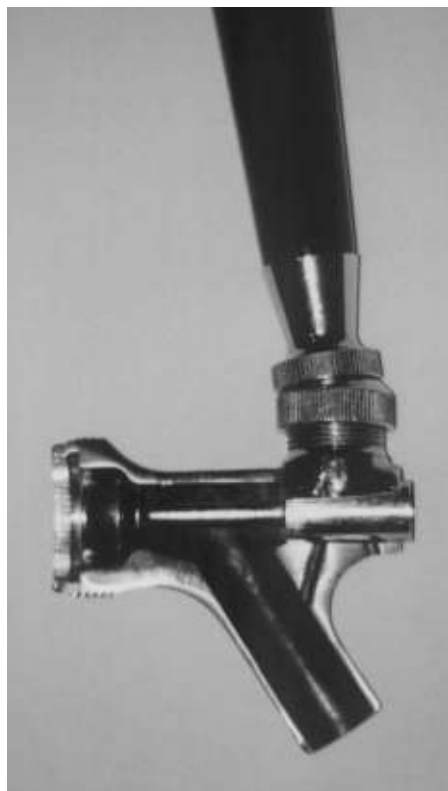
Photo 3. Traditional brass faucet with rough "pitted" brass surface

The valve is further up in traditional faucets (photo 3). This allows airborne microorganisms to rise up in the faucet as the beer drains out of the faucet, when the valve is shut. Consequently, any contaminant in the faucet valve can be carried back into the line when

the faucet is opened as the valve plunges back into the beer flow. Furthermore, the micro pitted pockets in the chrome plated brass faucets could permit unwanted bacterial and yeast growth (photo 3). The lower bacteria and yeast counts, observed in beer drawn from stainless steel faucets, could prove beneficial in prolonging beer flavor, stability, and saleability.

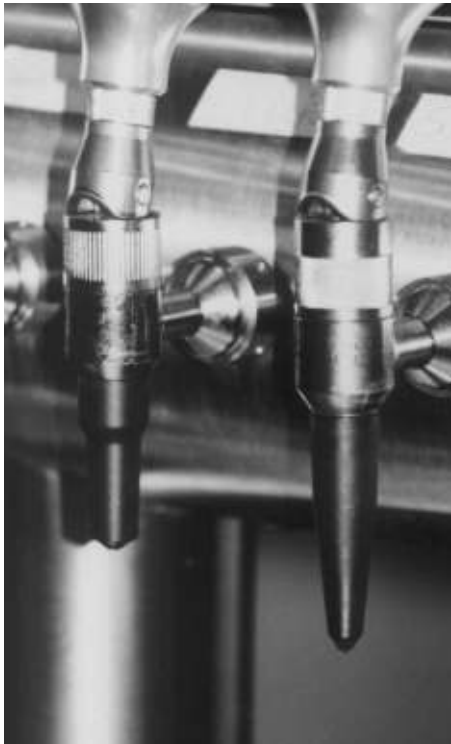
Photo 4. Note beer “droplet” at end of nozzle

Both the design of the stainless steel faucets and stainless steel's resistance to corrosion are responsible for the lower numbers of bacteria and yeast recovered from the beers drawn from these faucets. The beer valve in the Stainless One faucet shuts off just above the nozzle creating a vacuum and surface tension which holds a droplet of beer in suspension at the end of the nozzle (photos 4, 5). This droplet and valve location not only

prevent the influx of airborne bacteria into the faucet, but also inhibit the backflow of possible contaminants into the faucet and line. As the faucet is opened, the droplet cannot be lifted into the faucet valve.
