BY LORRAINE D. DOUCET AND FORREST THORNTON

# Stainless steel vs. brass faucets: A study

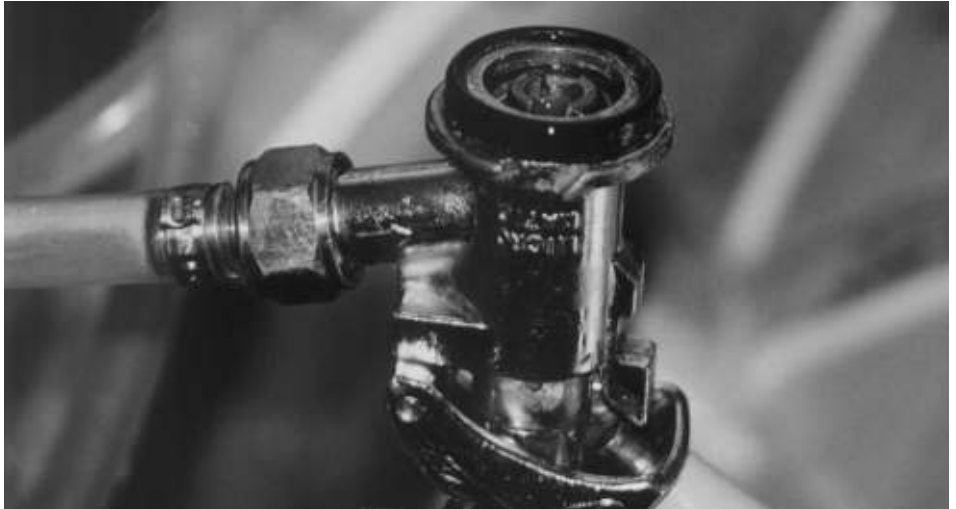
Photo 1. Keg coupler revealing brass surface

Examination of traditional chrome plated keg couplers, "Y" wall brackets, shanks, and faucets revealed that the chrome was completely eroded thus exposing the beer to the porous brass which contained many pitted areas (see photos 1, 2 and 3).

Erosion of copper and lead from a chrome plated brass dispensing system and components were evident in this study. Plates 1, 2 and 3 show erosion of the chrome plating and pitted areas within the interior of the brass keg coupler and faucet. Tables 7, 8 and 9 indicate leaching of the copper and lead from the brass alloy which altered the organoleptic quality of the beer as indicated by the taste test conducted in this study.

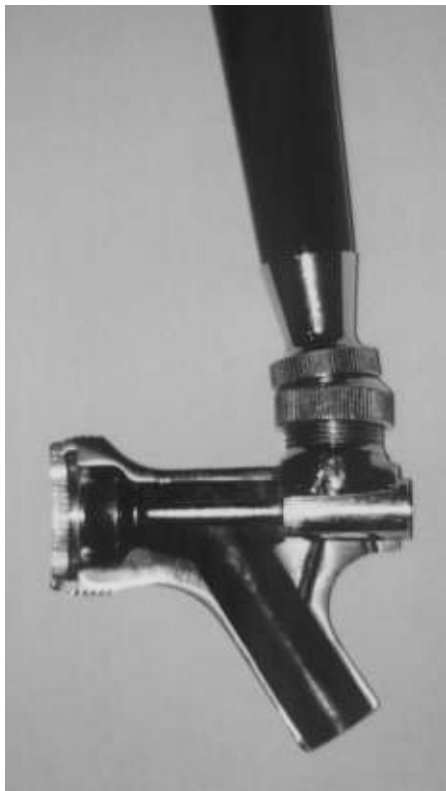
**Photo 3. Traditional brass faucet with rough "pitted" brass surface**

The valve is further up in traditional faucets (photo 3). This allows airborne microorganisms to rise up in the faucet as the beer drains out of the faucet, when the valve is shut. Consequently, any contaminant in the faucet valve can be carried back into the line when

the faucet is opened as the valve plunges back into the beer flow. Furthermore, the micro pitted pockets in the chrome plated brass faucets could permit unwanted bacterial and yeast growth (photo 3). The lower bacteria and yeast counts, observed in beer drawn from stainless steel faucets, could prove beneficial in prolonging beer flavor, stability, and saleability.

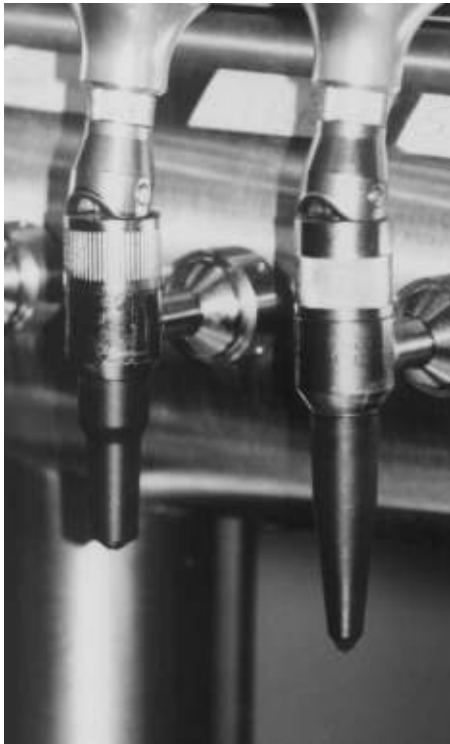
**Photo 4. Note beer “droplet” at end of nozzle**

Both the design of the stainless steel faucets and stainless steel's resistance to corrosion are responsible for the lower numbers of bacteria and yeast recovered from the beers drawn from these faucets. The beer valve in the Stainless One faucet shuts off just above the nozzle creating a vacuum and surface tension which holds a droplet of beer in suspension at the end of the nozzle (photos 4, 5). This droplet and valve location not only

prevent the influx of airborne bacteria into the faucet, but also inhibit the backflow of possible contaminants into the faucet and line. As the faucet is opened, the droplet cannot be lifted into the faucet valve.
